GLENDALE CHANNEL CLEANING REPORT – 2007

Report

Redfish Services

July 22, 2007

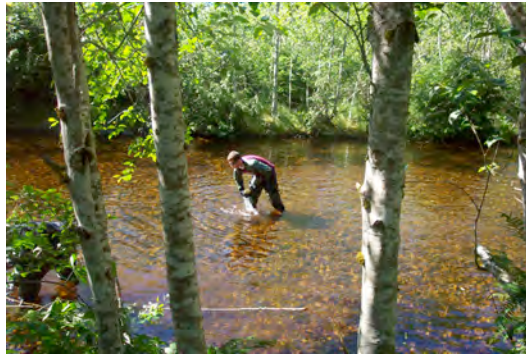
Since cobble removal from the beds would not be possible due to poor visibility once cleaning started, two passes down the full length of each channel leg was done. (Photo 1)

Photo 1 – Removing large rocks from beds

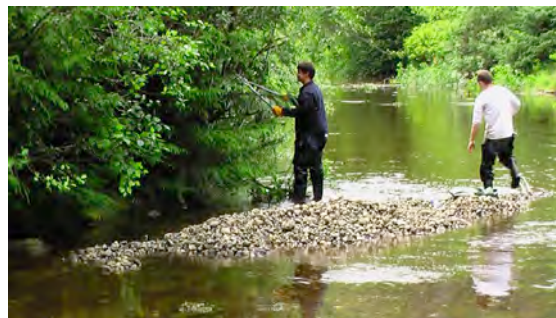
Another, two-man crew began the limbing of the lower riparian growth to allow the excavator operator to see well enough to clean up to the bed edges. All limbs were placed on the berms. (Photo 2)

Photo 2 – Limbing lower branches

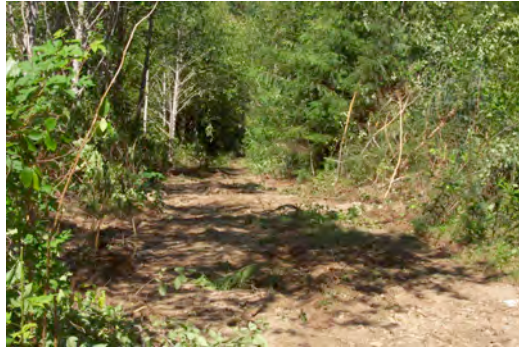
Photo 3 – Access road

Nearly 20 years of alder growth needed to be removed. Access points were punched in - one at the bottom of Leg 3, the other at the bottom of Leg 6. (Photos 3 and 4)

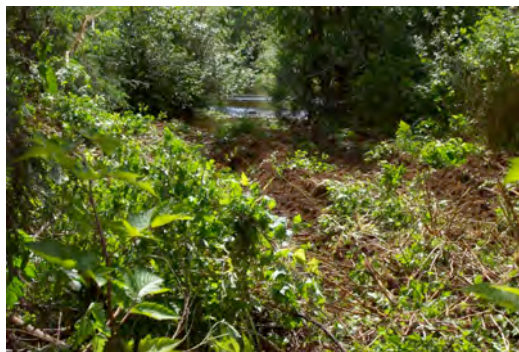
Photo 4 – Entry – exit to the channel leg

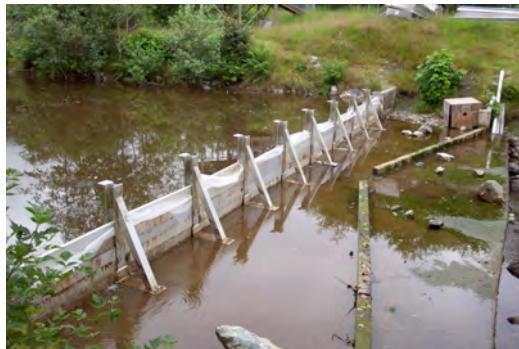
With flows reduced, stop logs with a plastic lining were placed at the channel outlet to retain any turbid water. (Photo 5)

Photo 5 – Outlet plastic-lined dam

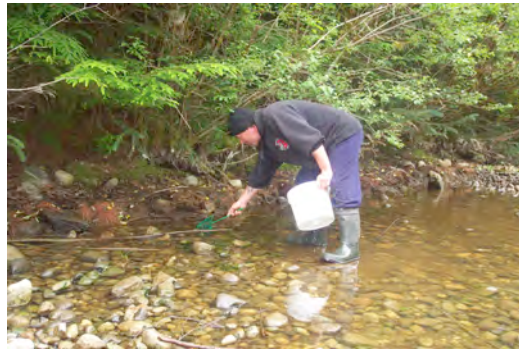
A retaining, plastic-lined gravel dam was made, pump intake hoses placed and the containment area behind the dam was pumped out. Fish salvage was conducted in this area. (Photos 6 and 7)

Photo 6 – Fish Salvage

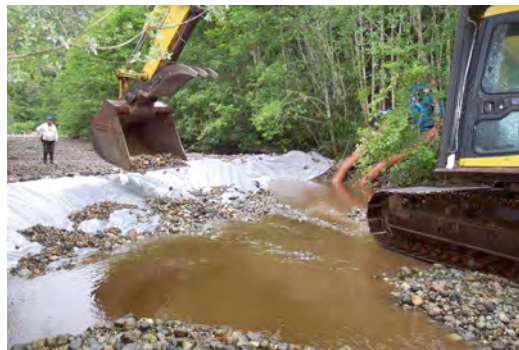
Photo 7 – Gravel plastic lined dam at first pumping station

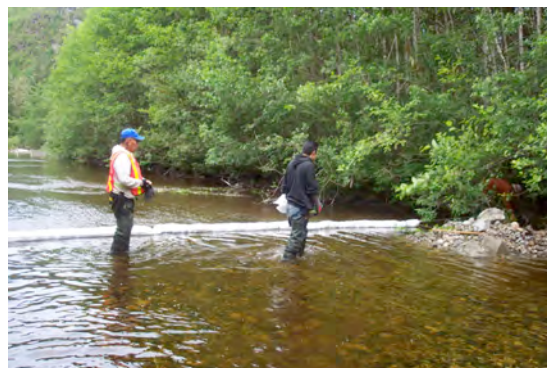
Two spill containment booms were placed in the channel legs in the event of a hydraulic oil spill. (Photo 8)

Photo 8 – Spill containment boom

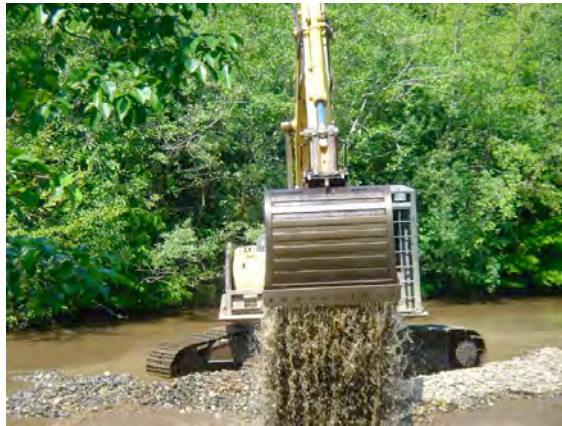
The scoop and recast cleaning method, as described in the Gravel Assessment Report, was used. (Photo 9) To briefly recap: Using the water and current to flush out the silt and organic matter, including large numbers of dead eggs, the excavator scooped up and recast the gravel over a broad area until the gravel appeared clean and the bulk of the brown organic

Photo 9 – Scoop and recast cleaning method

matter was flushed out. This process was repeated three or four times in each area before the excavator was moved a short distance downstream. As cleaning continued, a progressively deeper layer of organic goop accumulated behind the machine. In order to move this material, it was necessary for the excavator to repeatedly rotate and plunge the bucket up and down vigorously, forcing this sludge downstream. During this necessary process, many small branches, extending well over the channel beds were broken off. These branches found their way to the pump intake screens and plugged them up, necessitating several cleanings per day. There was also a continual concern of the sharp ends of the broken limbs rupturing the hydraulic line hoses. (Photos 10 and 11)

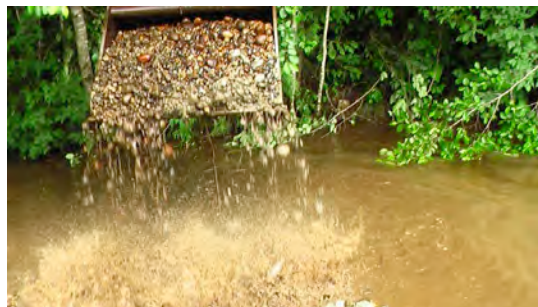
Photo 10 – Cleaning close to the berms

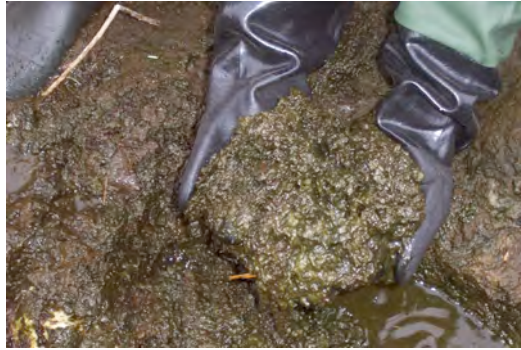
Photo 11 – Accumulated organic goop

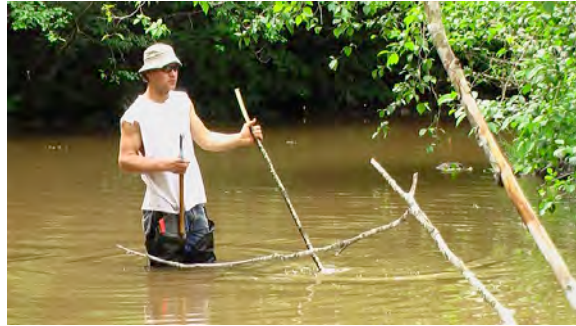
It was necessary to mark out and flag all the holding pools in the channel legs. (Photo 12) Once cleaning started, it was important to find them to prevent the excavator from backing into one. The ‘planned’ drawings in the authors’ possession did not reflect the ‘as-built’ locations.

Photo 12 - Marking the deep pools

Pool Removal – Holding pools were ill-conceived ideas that have more disadvantages than benefits. This is now understood and these pools have been filled in and the area used to increase spawning area. The Horsefly Channel is one example. It is recommended that this be done at Glendale Channel, especially since a stored gravel source is available on site. In the mean time, when another cleaning takes place, the use of small trash pumps would remove some of the deleterious matter. This process may not be possible at all six pool locations.

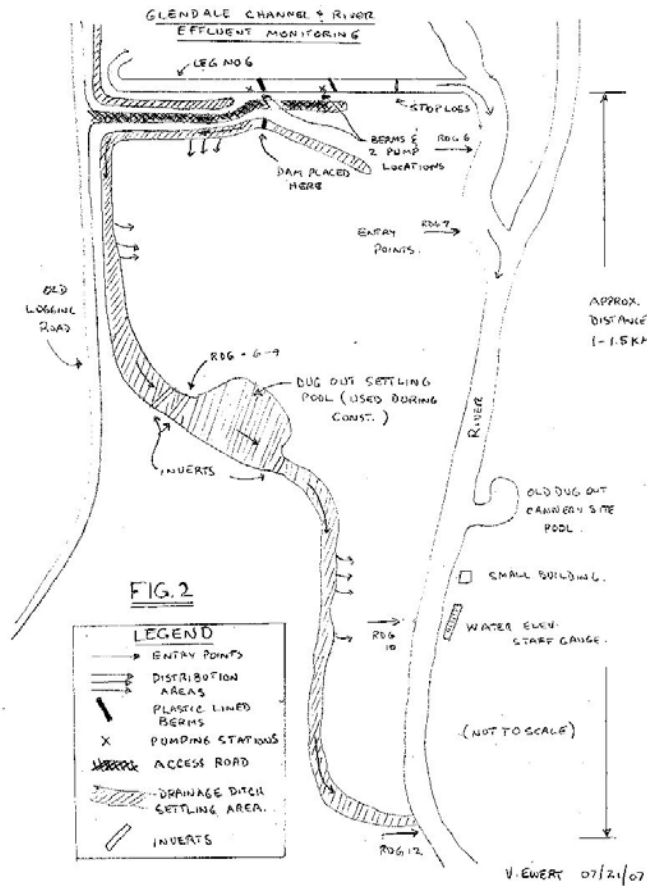
Fig. 2

The First Nations personnel, Alfred Coon and James Speck Jr., took daily sediment wedge readings as well as flagged and brushed out trails along both the left bank of the river as well as along the drainage ditch complex after the pumps were relocated. (Fig. 2)

After one and a half days of cleaning and pumping at the first location, a small amount of organic laden water, estimated to be .5 cfs (.01 cu/m/s), was observed entering the river at two locations nearest to the channel outflow area. (Fig. 2) No other entry points were discovered over a downstream distance estimated to be 1.5 km.

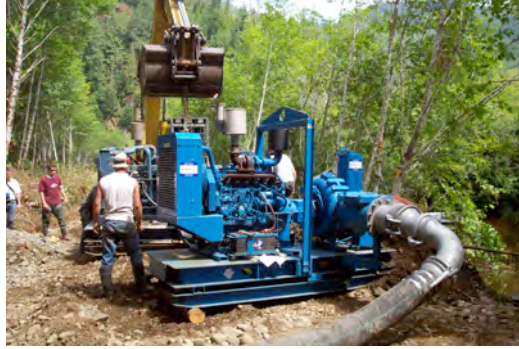
Cleaning was stopped and an alternate area was searched for. An extensive network of drainage ditches and settling areas was discovered. (Photos 13 and 14)

Photo 13 – Second pumping station

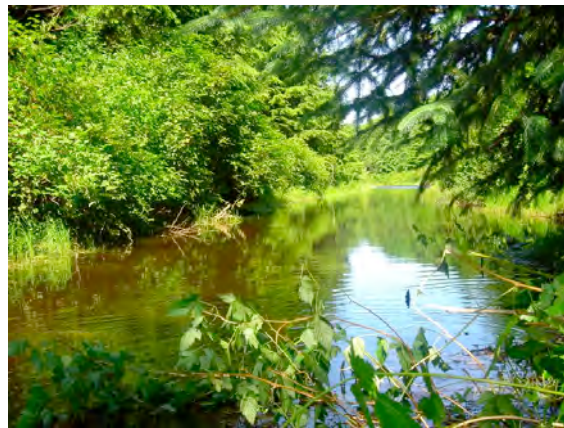
Photo 14 – Drainage ditch

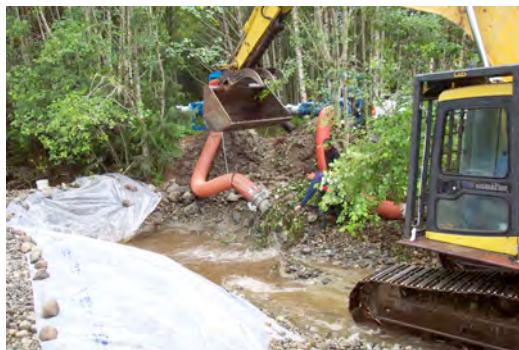
To encourage flows in the desired direction, away from the river, a dam was put in a ditch adjacent to the cleared roadway to Station No. 1. (Fig. 2) This second location, Photo 15, approximately one-half way down Leg 6, (Fig. 1) proved superior with the vast majority of flow going down the ditches and into the settling areas. It overflowed at various points onto the forest floor. A total reentry amount of approximately 1 cfs, (.021 cu/m/s), or less than 2.5 % of the volume pumped was noted in four locations over the monitored area. A metered stick was used to ensure no backup of levels occurred. Sediment wedge readings are covered in the summary section.

Photo 15 - Plastic-lined dam and second pumping station – Cleaning the intake screens

The second station also had a plastic-lined dam below the pumps and this gave two holding areas for dirty water. (Photo 15) It was observed that since only the top sides of the dams were plastic-covered, once pumping started again (one pump shut down at a time) after the cleaning of the screens, the dirty water flowed back through the gravel dams and was pumped out. This ensured that while servicing the screens, this accumulated dirty water could effectively be removed.

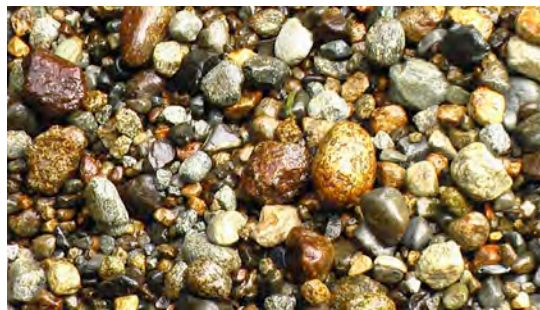
With the exception of Leg 2, after the cleaning/remixing was done, the gravel composition had the appearance and texture of a well-mixed, clean, fluffy gravel bed. Leg 2 appeared visually to lack the same amount of smaller particles as the other legs. The volume of gravel expanded visibly due to the loose nature of the medium. (Photos 16 and 17)

Photo 16 – Cleaned gravel with a good mix

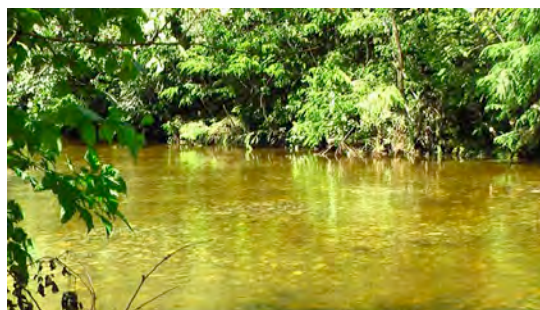
Photo 17 – Cleaned gravel beds

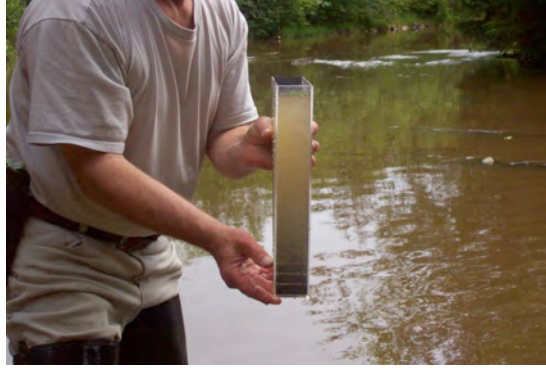
Sediment wedge readings, using the Triton Sediment Wedge showed, as expected, that the lowest -0- (dirtiest) readings were close to the cleaning process with readings progressively higher over distance. (Photos 18 and 19)

Photo 18 – Sediment wedge readings

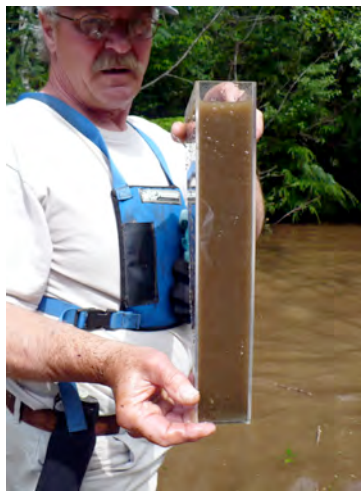
Photo 19 – Sediment wedge reading
