GLENDALE CHANNEL CLEANING REPORT – 2007

Report

Redfish Services

July 22, 2007

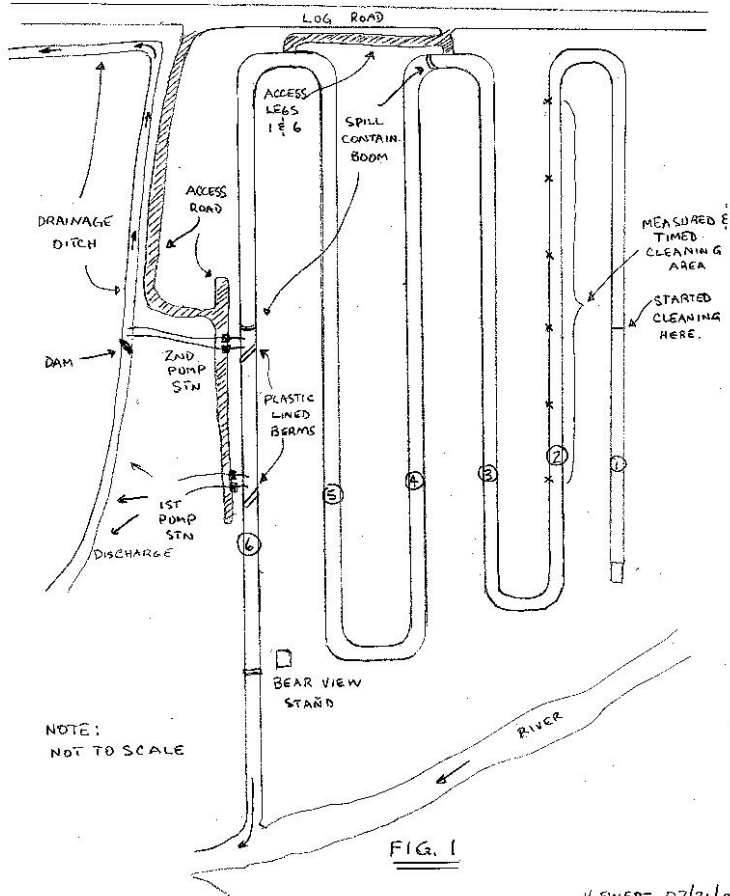
GLENDALE CHANNEL GRAVEL
CLEANING

All of the pumping gear was placed at the first pumping location. (Fig. 1)

After one and a half days of cleaning and pumping at the first location, a small amount of organic laden water, estimated to be .5 cfs (.01 cu/m/s), was observed entering the river at two locations nearest to the channel outflow area. (Fig. 2) No other entry points were discovered over a downstream distance estimated to be 1.5 km.

To encourage flows in the desired direction, away from the river, a dam was put in a ditch adjacent to the cleared roadway to Station No. 1. (Fig. 2) This second location, Photo 15, approximately one-half way down Leg 6, (Fig. 1) proved superior with the vast majority of flow going down the ditches and into the settling areas. It overflowed at various points onto the forest floor. A total reentry amount of approximately 1 cfs, (.021 cu/m/s), or less than 2.5 % of the volume pumped was noted in four locations over the monitored area. A metered stick was used to ensure no backup of levels occurred. Sediment wedge readings are covered in the summary section.

The entry points (Fig. 1) allowed for the entry and exit of the excavator for daily servicing and fuelling. No fuelling was done in the channel. Cleaned areas were not traveled on by the machine once cleaned. Travel in and out was restricted to the nearest downstream entry point as cleaning progressed.
